# Area-Based Closure Site Inspection

<b>YOUR COMPANY HERE</b>		(555) 555-5555	
<b>REDACTED</b>		you@yourcompany.com	
Sherwood Park, <b>XXX XXX</b>		https://YourCompany.com	
Client	<b>REDACTED</b>	Location	0X-2X-0XX -0XXXM
Program Type	Area-Base Closure Site Inspection (ESA P1+)	Program Number	2XX-0XXX8

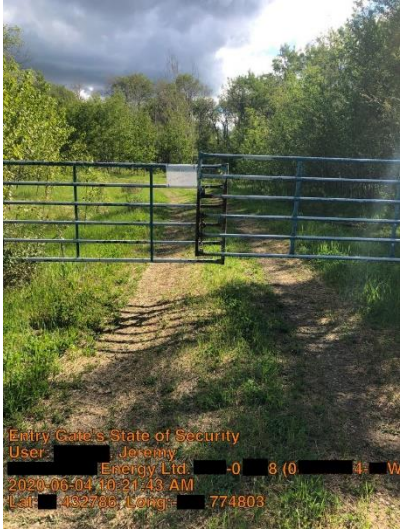
Type of Site	Single Well	Type of Production	Oil
Current Land Use(s)	Natural	Other Land Use Description	
Access Restrictions?	False	All Access Restrictions	
Gate Access Code (if applicable)		Other Access Restriction Description	
Was the Land Owner Contacted?	True	Land Owner Comments?	None
Public or Private	Private Land	Date and Time of Arrival	6/4/2020 4:12 PM
Are notable Odors Present?	False	Describe Odor	
Are Overhead Powerlines Present?	False	Is there H2S Present?	False
Is the Site Entrance Gate Chained or Locked?	True

<p>Entry Gate's State of Security User: [redacted] Jeremy [redacted] Energy Ltd. 2 [redacted] 8 (0) [redacted] W 2020-06-04 10:21:43 AM Lat: 432786, Long: 774803</p>
