YOUR COMPANY HERE		(555) 555-5555	
REDACTED		you@yourcompany.com	
Sherwood Park, XXX XXX		https://YourCompany.com	
Client	REDACTED	Location	0X-2X-0XX -0XXXM
Program Type	Area-Base Closure Site Inspection (ESA P1+)	Program Number	2XX-0XXX8

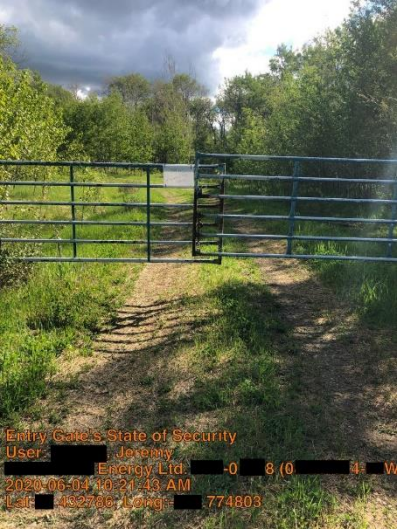
<p>Entry Gate's State of Security User: [redacted] Jeremy [redacted] Energy Ltd. [redacted] 8 (0) [redacted] W 2020-06-04 10:21:43 AM Lat: 432786 Long: 774803</p>
