Vegetation Management

Client	Liberty Petroleum	Location	AMU D-519 HR
Program Type	Vegetation Management	Program Number	20E-01127

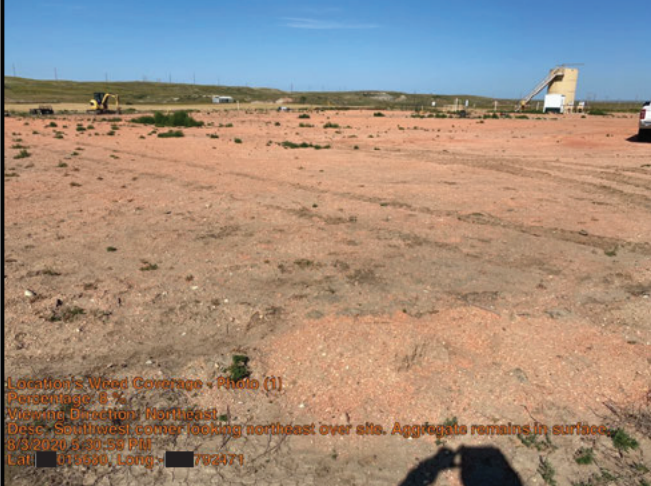
<p data-bbox="113 756 760 861"> Location's Weed Coverage - Photo (1) Percentage: 8 % Viewing Direction: Northeast Desc: Southwest corner looking northeast over site. Aggregate remains in surface. 8/3/2020 5:30:59 PM Lat: 01000, Long: 709571 </p>	<p data-bbox="982 346 1274 378">Crop Coverage Photo</p>

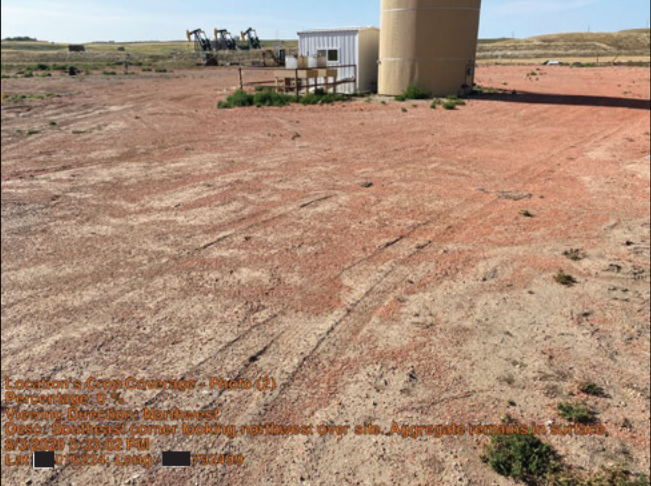
<p data-bbox="803 756 1450 861"> Location's Crop Coverage - Photo (2) Percentage: 0 % Viewing Direction: Northwest Desc: Southwest corner looking northwest over site. Aggregate remains in surface. 8/3/2020 5:30:52 PM Lat: 01000, Long: 709571 </p>
<p data-bbox="300 934 576 966">Desirable Veg Photo</p>

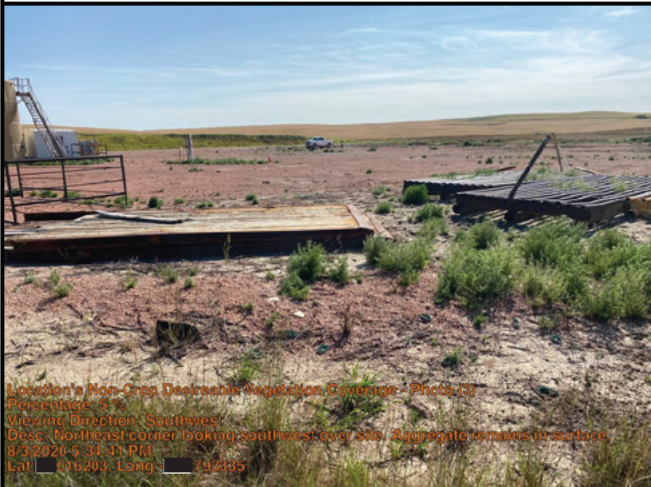
<p data-bbox="113 1344 760 1449"> Location's Non-Crop Desirable Vegetation Coverage - Photo (3) Percentage: 3 % Viewing Direction: Southwest Desc: Northeast corner looking southwest over site. Aggregate remains in surface. 8/3/2020 5:31:31 PM Lat: 01000, Long: 709535 </p>	<p data-bbox="1015 934 1242 966">Bare Land Photo</p>

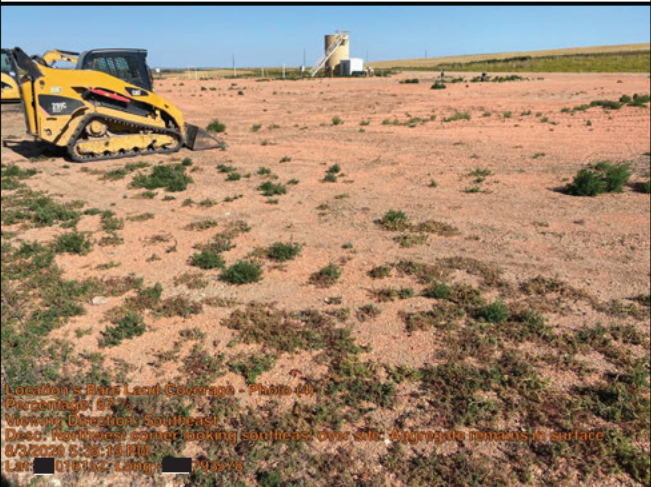
<p data-bbox="803 1344 1450 1449"> Location's Bare Land Coverage - Photo (4) Percentage: 87 % Viewing Direction: Southwest Desc: Northeast corner looking southwest over site. Aggregate remains in surface. 8/3/2020 5:31:28 PM Lat: 01000, Long: 709535 </p>

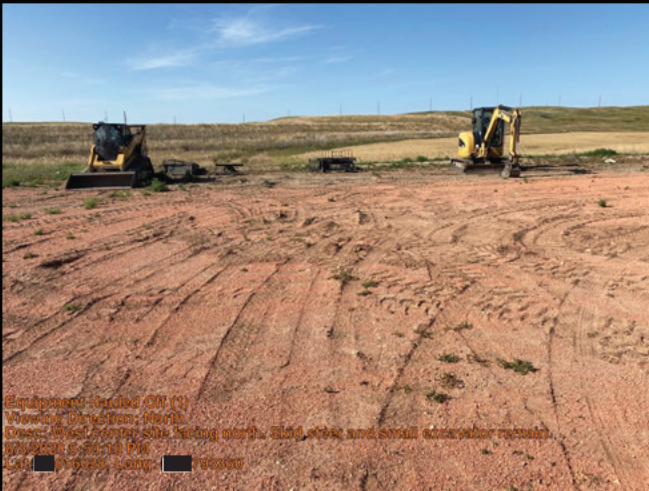
<p data-bbox="115 821 667 905">Equipment Hauled Off (1) Viewing Direction: North Desc: West corner site looking north. Small tractor and small excavator remain. 8/3/2020 5:56:15 PM Lat: 37.10000 Long: -79.25500</p>	<p data-bbox="1065 392 1183 422">Photo - 2</p>

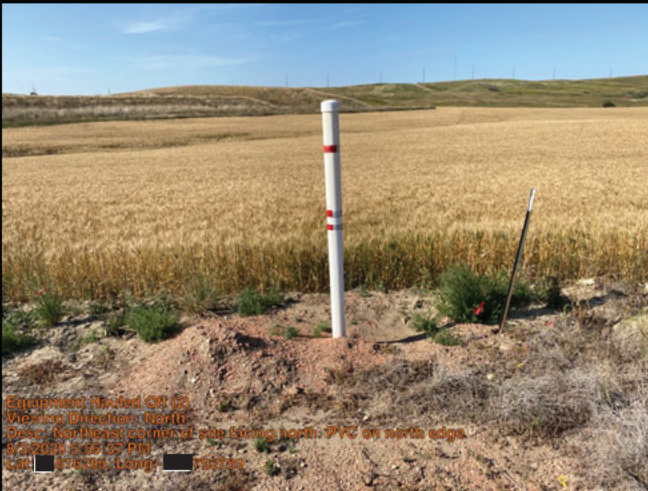
<p data-bbox="802 821 1265 905">Equipment Hauled Off (2) Viewing Direction: North Desc: Northeast corner of site looking north. PVC on north edge. 8/3/2020 5:56:25 PM Lat: 37.10000 Long: -79.25500</p>
<p data-bbox="378 972 496 1001">Photo - 3</p>

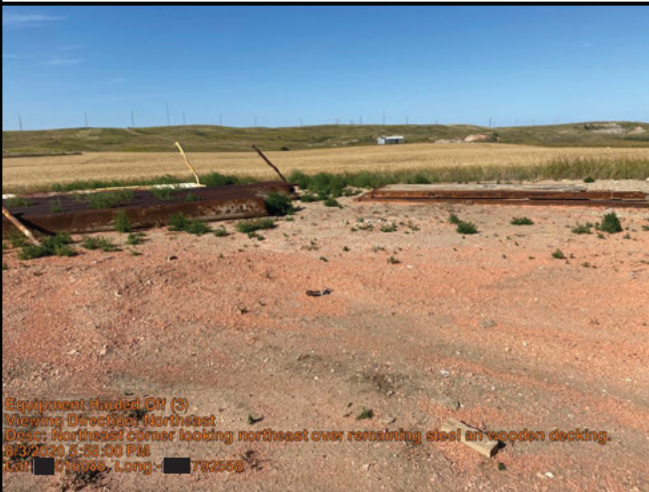
<p data-bbox="115 1413 724 1497">Equipment Hauled Off (3) Viewing Direction: Northeast Desc: Northeast corner looking northeast over remaining steel on wooden decking. 8/3/2020 5:58:00 PM Lat: 37.10000 Long: -79.25500</p>	<p data-bbox="1065 972 1183 1001">Photo - 4</p>

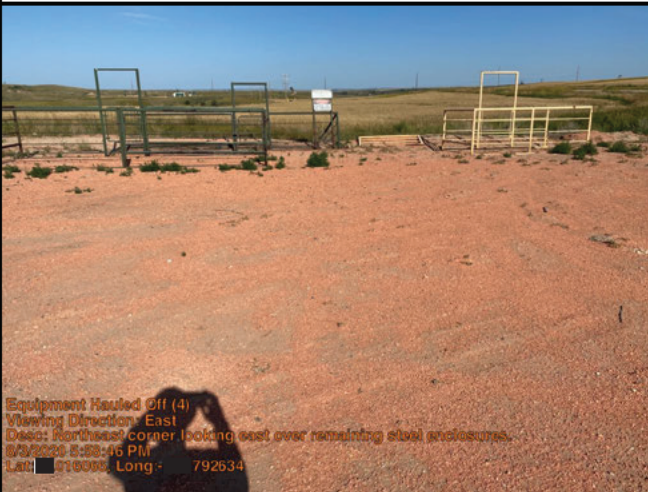
<p data-bbox="802 1413 1308 1497">Equipment Hauled Off (4) Viewing Direction: East Desc: Northeast corner looking east over remaining steel enclosure. 8/3/2020 5:58:16 PM Lat: 37.10000 Long: -79.25340</p>

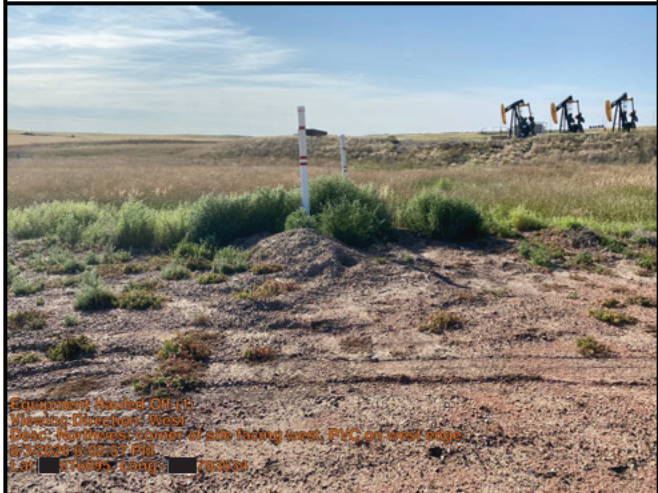
<p data-bbox="115 821 570 905">Equipment hauled off (1) Viewing Direction: West Desc: Northwest corner of site facing west, PVC at east edge 8/23/2020 1:02:07 PM Lat: 33.8804, Long: -109.8238</p>	<p data-bbox="1065 390 1183 422">Photo - 2</p>

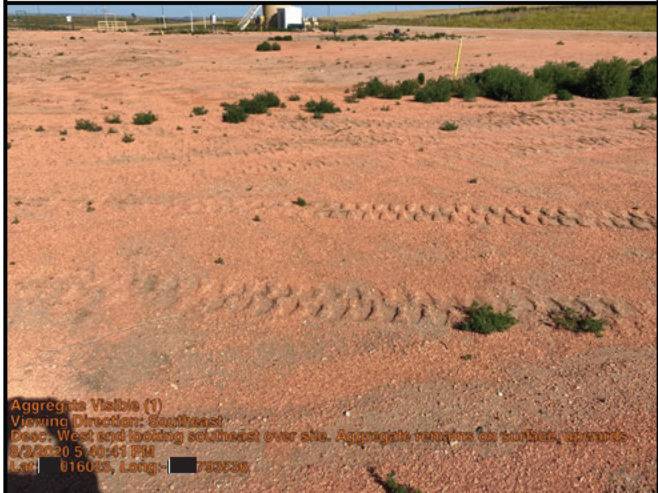
<p data-bbox="115 1514 732 1598">Aggregate Visible (1) Viewing Direction: Southeast Desc: West and looking southeast over site. Aggregate remains on surface, sparse 8/23/2020 5:40:41 PM Lat: 33.8804, Long: -109.8238</p>
