Land Consultation Site Inspection

Environmental Services Inc.		555.960.1935	
2021 Liberty Place Suite 250		example@enviroserv.com	
Houston, TX 77380		https://enviroserv.com	
Client	USA Oil & Gas Co.	Location	Conquest
Program Type	Land Consultation (General)	Program Number	10-07291
[01] - Land Consultation			
Current Land Use	Agricultural	Other Land Use Description	
Landowner or Occupant consent to plough	Yes	Who will complete the ploughing?	Contractor
Who is responsible to Reseed Grass?	Landowner/Tenant	Reseed Grass Requirements	
Which Topsoil will be stripped?	Dig Site	Gate Required	No
Livestock Present in Construction Area?	Yes	Landowner Remediation From signed?	
Temporary Fencing Required?	Yes	Who is responsible for Fence Removal?	Contractor
Fencing Details	Need fencing to contain livestock	Compaction Relief Required?	Yes
Who is responsible for Compaction Relief?	Contractor	Constructin Req Comments	
Damages to be Prepaid?	No	Who will be paid for damages?	Landowner

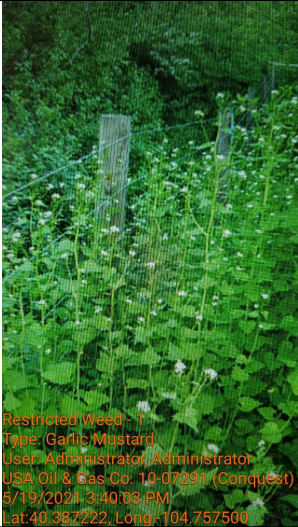
[02] Access Veg & Weeds		[02] Access Veg & Weeds	
Restricted Weed Photo - 1		Access Photo - 1

Access Vegetation Observed		Cultivated (Annual), Hay, Native Pasture		Access Cultivated Crops		Hayland Mix, Winter Wheat		
Crop Land Irrigated?		Yes		Irrigation Method		Flood Irrigated		
Livestock within Pasture?		Yes		Items included in Pasture Land		Fencing, Cattle Guards		
Are there any Weeds observed Off-Site?		Yes						
Noxious Weeds		Coverage %	Nuisance Weeds		Coverage %	Restricted Weeds		Coverage %
No Noxious Weeds Found			No Nuisance Weeds Found			Garlic Mustard		8

<p>Restricted Weed - 1 Type: Garlic Mustard User: Administrator, Administrator USA Oil & Gas Co. 10-07291 (Conquest) 5/19/2021 3:40:03 PM Lat:40.387222, Long:-104.757500</p>

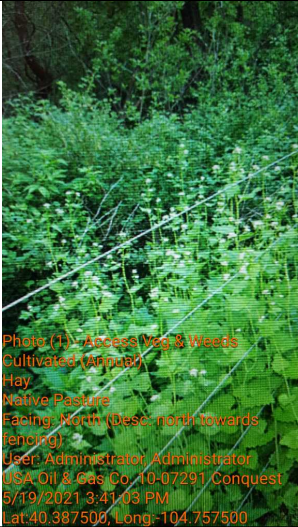
<p>Photo (1) - Access Veg & Weeds Cultivated (Annual) Hay Native Pasture Facing: North (Desc: north towards fencing) User: Administrator, Administrator USA Oil & Gas Co. 10-07291 Conquest 5/19/2021 3:41:03 PM Lat:40.387500, Long:-104.757500</p>	
Access Photo - 2

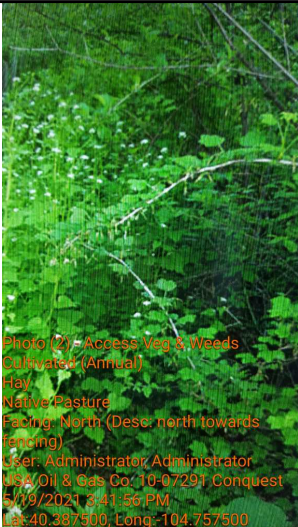
<p>Photo (2) - Access Veg & Weeds Cultivated (Annual) Hay Native Pasture Facing: North (Desc: north towards fencing) User: Administrator, Administrator USA Oil & Gas Co. 10-07291 Conquest 5/19/2021 3:41:56 PM Lat:40.387500, Long:-104.757500</p>

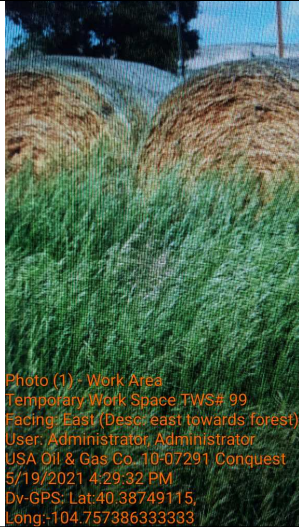
Work Area Photo - 1

Work Area Type	Temporary Work Space	GWD/Tract/TWS/LDA #	99		
Device or External GPS?	My Device's GPS	Lat/Long	XX.38749115 -104.757386333333		
Access Vegetation Observed	Timber, Hay	Access Cultivated Crops			
Crop Land Irrigated?		Irrigation Method			
Livestock within Pasture?		Items included in Pasture Land			
Are there any Weeds observed Off-Site?	No				
Noxious Weeds	Coverage %	Nuisance Weeds	Coverage %	Restricted Weeds	Coverage %
No Noxious Weeds Found		No Nuisance Weeds Found		No Restricted Weeds Found

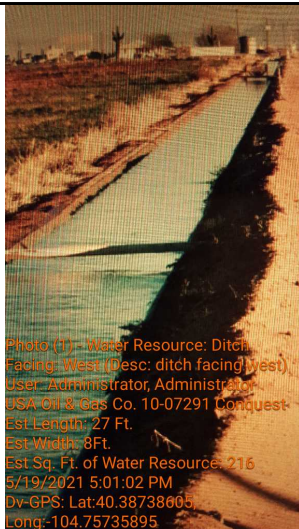
Water Resource Photo - 1

Type of Water Resource	Ditch	Use of Water Resource	Livestock
Location of Water Resource	On-Access (including buffer)	Estimating in Feet or Meters?	Feet
Length of Water Resource	27 Feet	Width of Water Resource	8 Feet
Depth of Water Resource	3 Feet	Distance to ROW Boundary or Access (Off-Site only)	
Area of Water Resource in Sq Ft	216 Sq. Feet	Area of Water Resource in Sq Meters	20.07 Sq. Meters
Device or External GPS?	My Device's GPS	Lat/Long	XX.38738605 -104.75735895
Water Resources Comments	ditch used for livestock

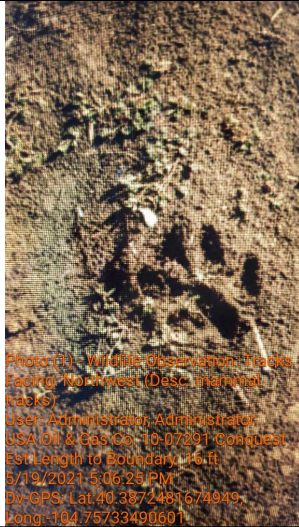
Wildlife Observation Photo - 1

[05] - Wildlife			
Type of Wildlife Observation	Tracks	Wildlife Observation Location	Off-Site
Estimating Distance in Feet or Meters (Off-Site only)	Feet	Distance to ROW Boundary or Access (Off-Site only)	16 Feet
Device or External GPS?	My Device's GPS	Lat/Long	XX.3872481674949 -104.75733490601
Wildlife Observation Comments	appear to be tracks of a small mammal

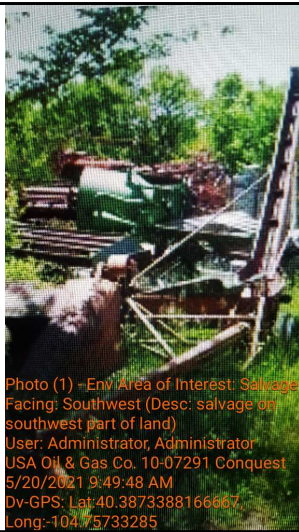
EAI Photo 1

[06] - EAI (Environmental Area of Interest)			
Selected EAI	Salvage	Adjacent Land Affected by EAI?	No
Device or External GPS?	My Device's GPS	Lat/Long	XX.3873388166667 -104.75733285

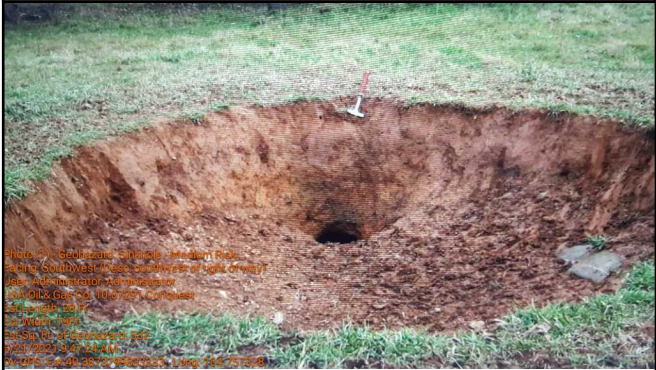
[07] Geohazard	[02] Access Veg & Weeds
<p data-bbox="315 344 561 373">Geohazard Photo 1</p>

[07] - Geohazard			
Geohazard Type	Sinkhole	Geohazard Risk Level	High
Location of Geohazard	On-Right of Way (including buffer)	Estimating in Feet or Meters?	Feet
Length of Geohazard	28 Feet	Width of Geohazard	19 Feet
Depth of Geohazard	3 Feet	Distance to ROW Boundary or Access (Off-Site only)	
Area of Geohazard in Sq Ft	532 Sq. Feet	Area of Geohazard in Sq Meters	49.42 Sq. Meters
Depth of Cover Information Added?	Yes	Depth of Cover Measured or Estimated?	Estimated
Measurement/Estimation Method	Field Estimated	Depth of Cover	16 Feet
Device or External GPS?	My Device's GPS	Lat/Long	XX.3873799833333 -104.757328
Geohazard Comments	seems to be getting larger

<p data-bbox="112 632 375 751">Photo 1 - Geohazard - 100m x 100m Photo 2 - South of hole - 100m x 100m Photo 3 - North of hole - 100m x 100m Photo 4 - Gas Gas 100m x 100m Photo 5 - Gas Gas 100m x 100m Photo 6 - Gas Gas 100m x 100m Photo 7 - Gas Gas 100m x 100m Photo 8 - Gas Gas 100m x 100m Photo 9 - Gas Gas 100m x 100m Photo 10 - Gas Gas 100m x 100m</p>
