Vegetation Management

Client	Liberty Petroleum	Location	AMU D-519 HR
Program Type	Vegetation Management	Program Number	20E-01127

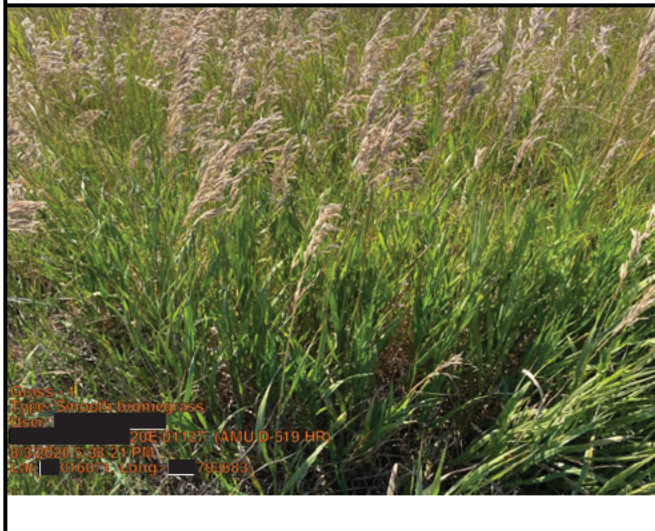
Grass Photo - 1

Crops	Coverage %	Grass	Coverage %	Forbs	Coverage %
No Crops Found		Smooth brome grass	5	No Forbs Found

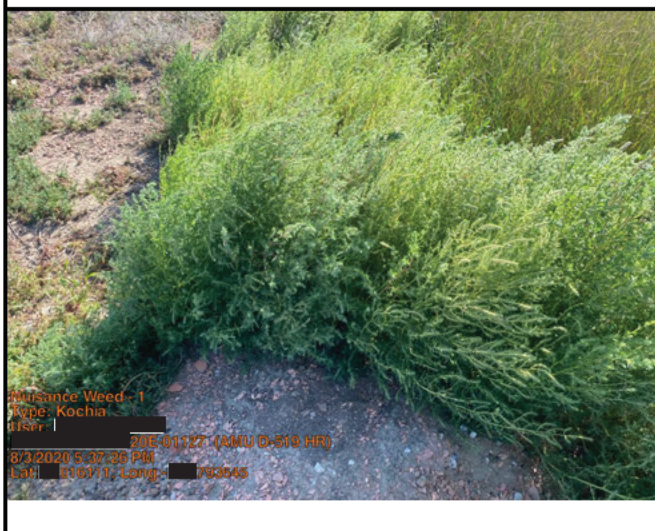
Nuisance Weed Photo - 1

[01d] - Weeds (On-Site)					
On-Site Weed Types			Nuisance		
Noxious Weeds	Coverage %	Nuisance Weeds	Coverage %	Restricted Weeds	Coverage %
No Noxious Weeds Found		Kochia	8	No Restricted Weeds Found	
Vegetation Management Methods			Herbicides		
Biological Methods					
Herbicidal Methods			2,4-D, Curtail, Stinger		
Mechanical Methods
